# **ENVIRONMENTAL ASSESSMENT**

## **GREAT FALLS COAL FIELD CLOGGED STREAMS ABANDONED MINE LANDS PROJECT CASCADE COUNTY, MONTANA**

**Prepared By:  
Montana Department of Environmental Quality  
Mine Waste Cleanup Bureau  
Abandoned Mines Land**

**May 2012**

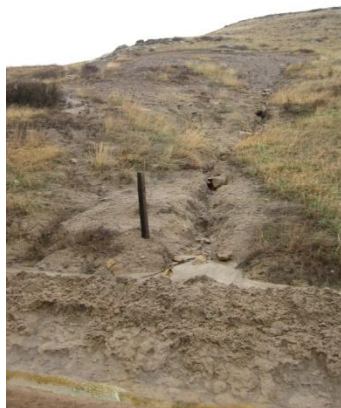
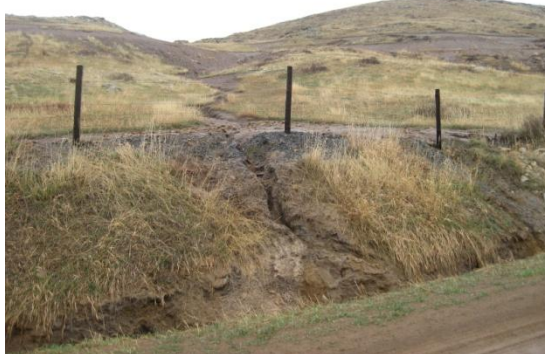
**1.0** Start seepage burnout area for #1 & #2 mines. Sedimentation and mine seepage discharge.

**1.1.** After crossing hump, north-side roadside ditch starts again. Mine seepage on hillsides along both sides of Cottonwood Coulee continues from #1 and #2 coal mines [Cottonwood Seeps].

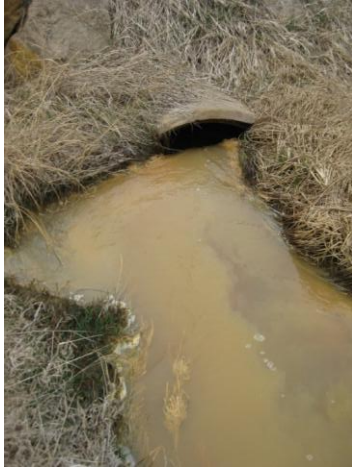
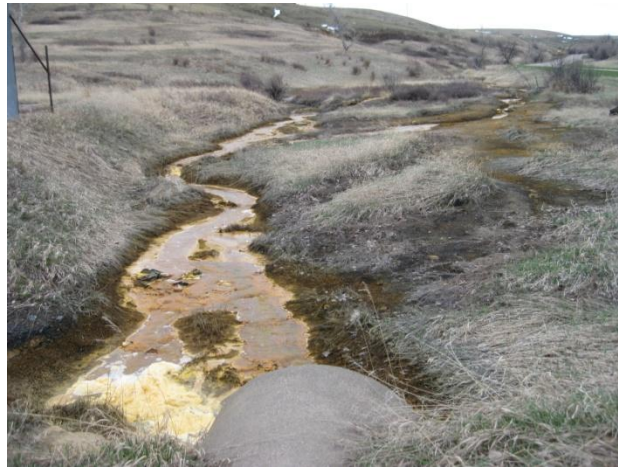
**1.5** Junction State Route 227. County road culvert with Cottonwood Creek crossing Cottonwood Coulee Road, flowing north. Culvert clogged with metals precipitation from #2 Mine discharge in Ladd Coulee.

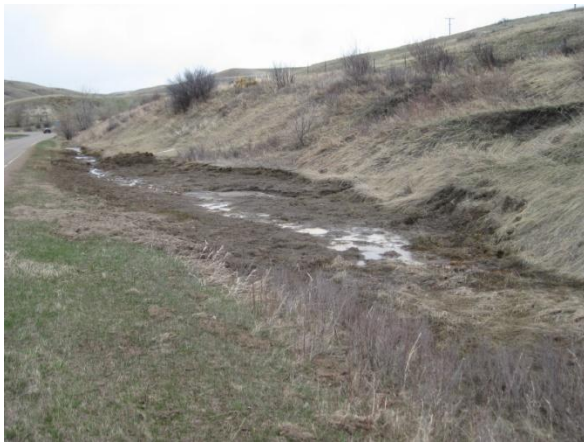
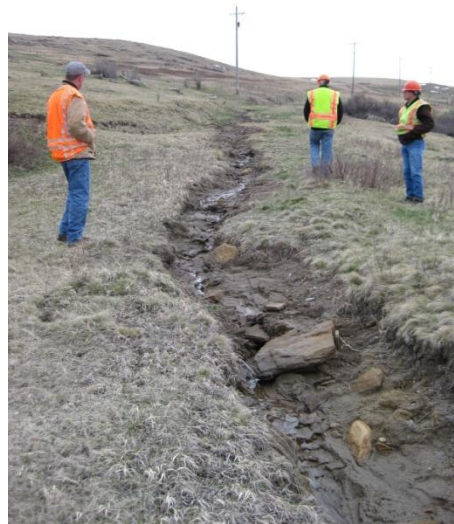
**0.1** Sloughing into roadside ditch from seepage area below #2 Mine.

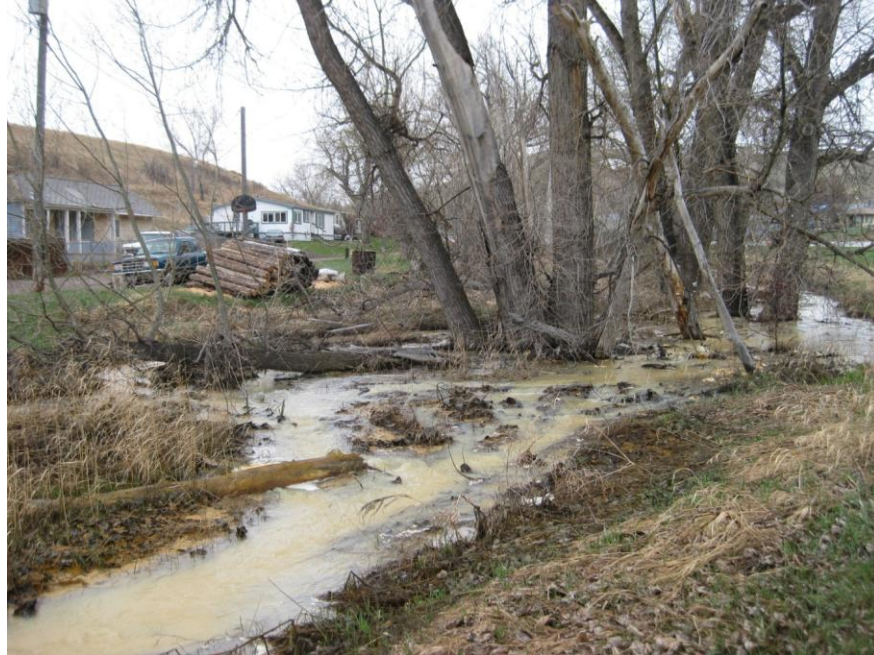
**0.4** Cottonwood Creek was flooding in a residential area due to filled channel capacity. In 2010 high water pushed the stream out-of-channel where it pooled on the street in front of houses on Dewey Ave.

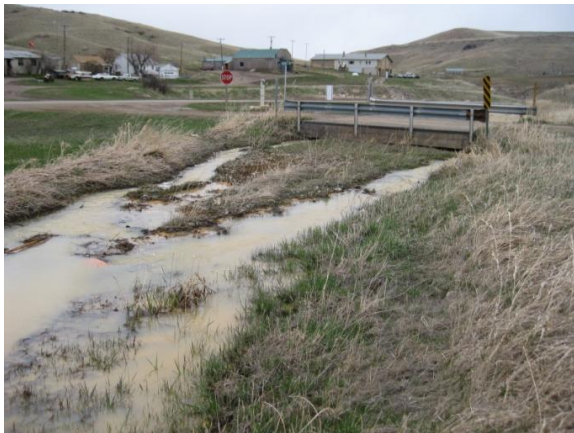
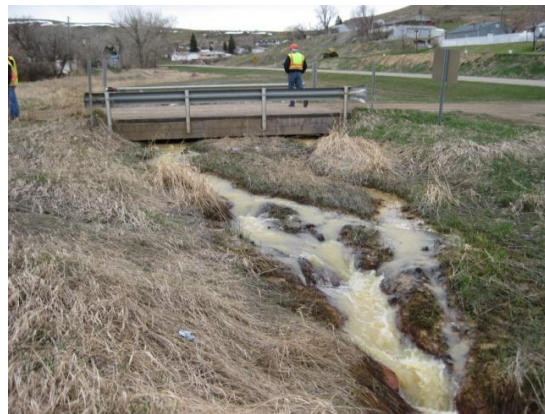
**0.6** Bridge at Dewey Avenue, Stockett. County Road Bridge crosses Cottonwood Creek. Waterway beneath bridge is blocked with sediment, resulting in a limited passage for the stream. High water in spring 2010 inundated the bridge.

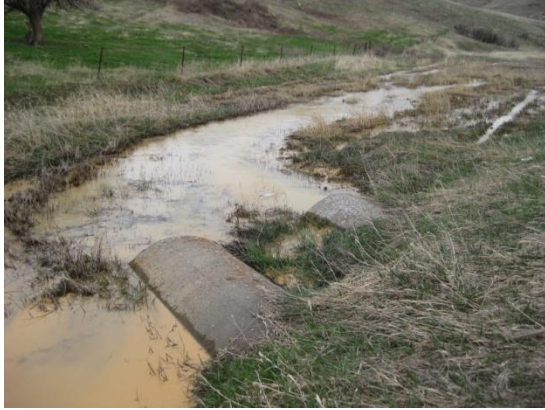
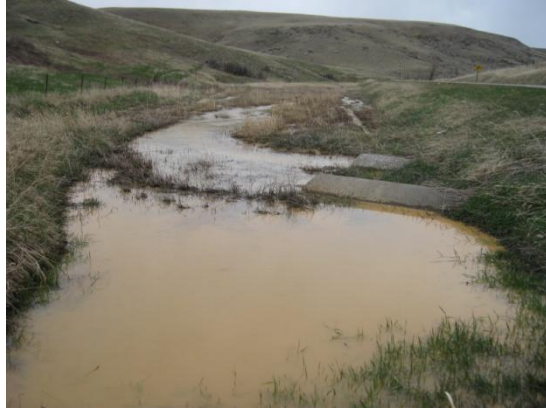
**1.2** Plugged Culvert. Cottonwood Creek crosses to the West side of the road. Clogging of the culvert has resulted from the aggraded stream bottom downstream from these culverts. These are twin concrete culverts and are located at 3 Rivers Telephone Building.

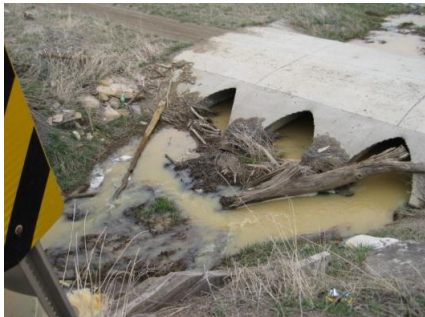
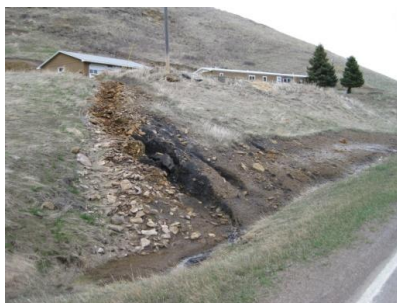
**1.8** Culvert crosses road to east. Cottonwood Creek is now on the east side of 227. Debris blockage observable.

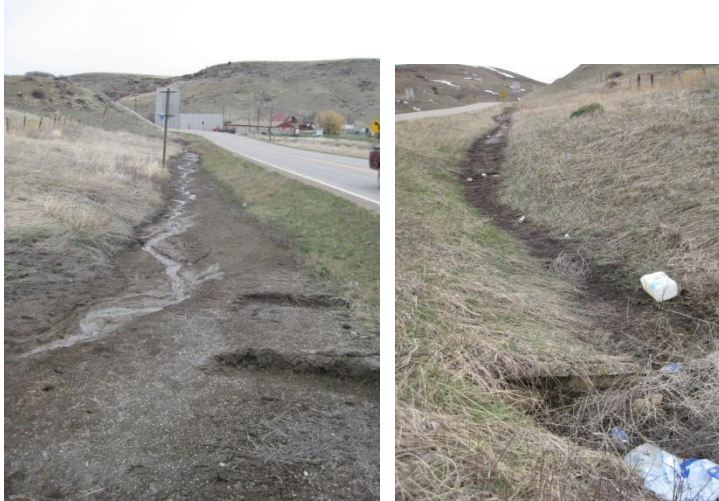
**2.8** Abandoned Stainsby and Latham Mine. West side of Route 227. Discharge from west hillside to culvert under road. Sedimentation from mine drainage prevents vegetation from establishing, which would stabilize the channel down slope.

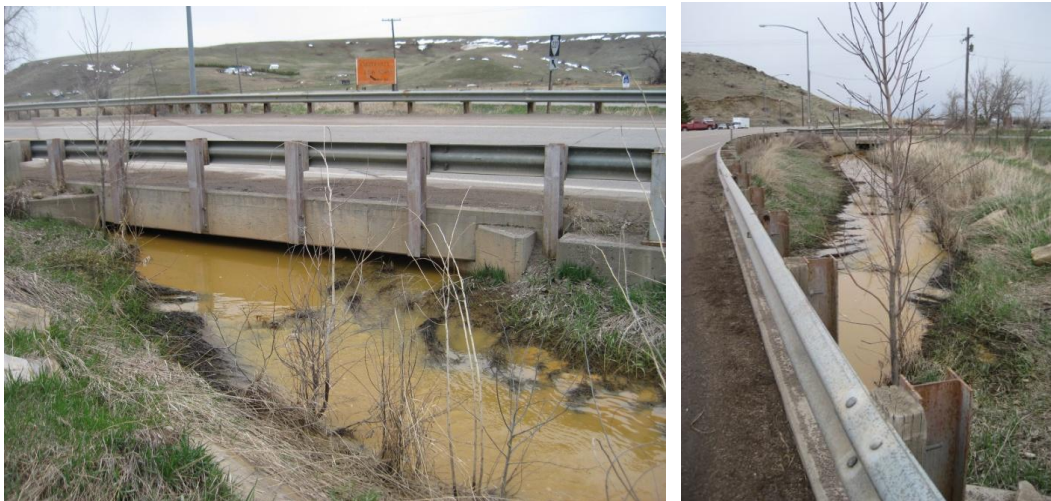
**5.0** Tracy: Two sets of plugged culverts. Twin, 4'x8' box culverts beneath 227 are plugged, as is the culvert beneath the county road leading into Tracy. Bridge culverts were installed in 1984.

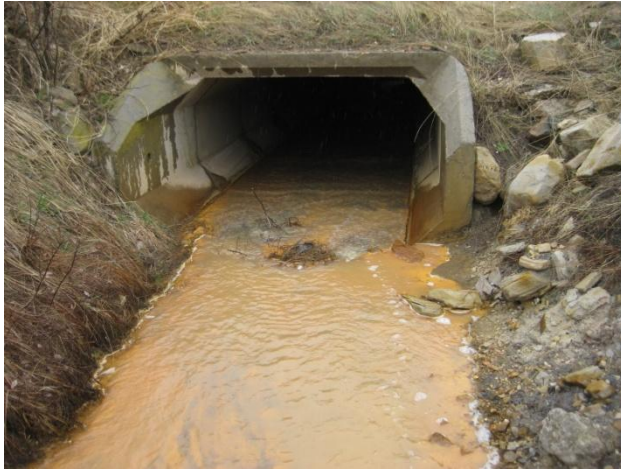
**0.0 Start:** East Hunter Road. South edge of Sand Coulee – Shack Town. Straight Creek – “Rusty Ditch.” Culvert located at Miners Coulee/Straight Creek confluence. Culvert under county road is not plugged. AMD discharges from Miners Coulee and Straight Creek flow into this culvert.

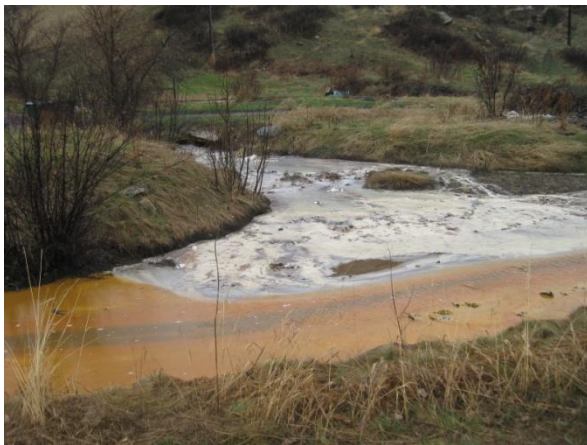
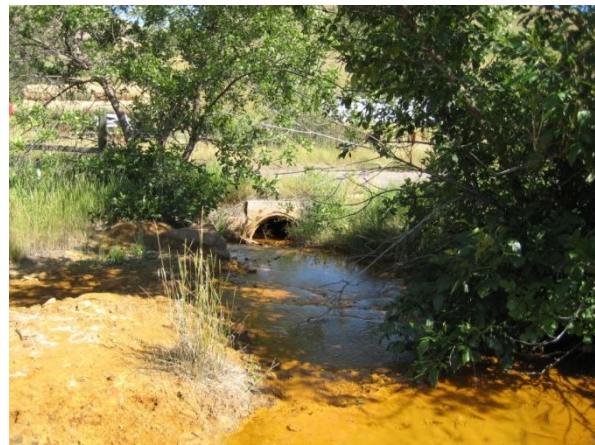
**0.1 “Kate’s Coulee” discharges to Straight Creek. Culvert under Shack Town road also plugged. Drainage from the National/Mount Oregon and Gerber Mines discharge into “Kate’s Coulee.”**

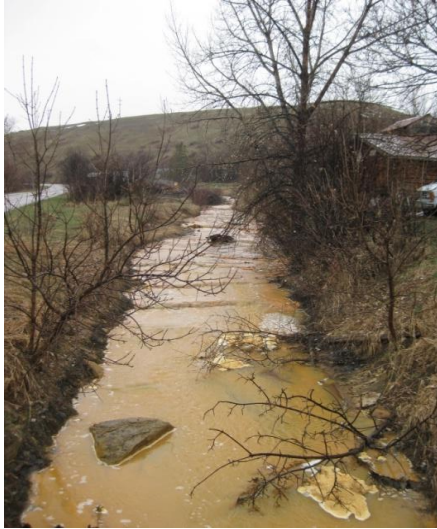
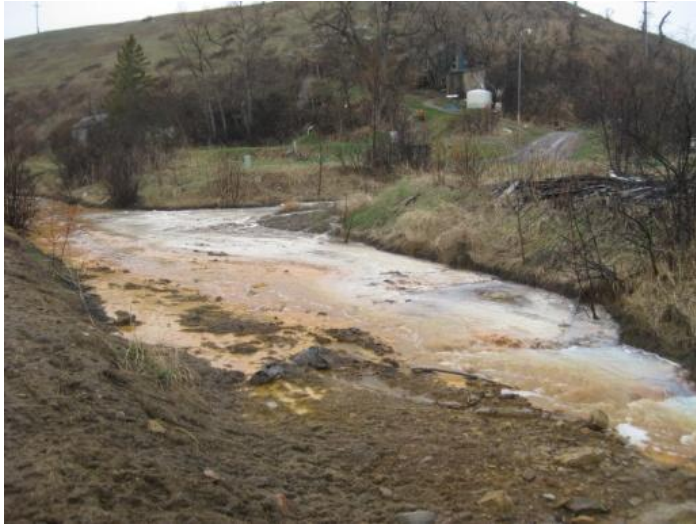
**0.2 Bridge – Finn Hall. Straight Creek filled with ferric hydroxide precipitates above bridge.**

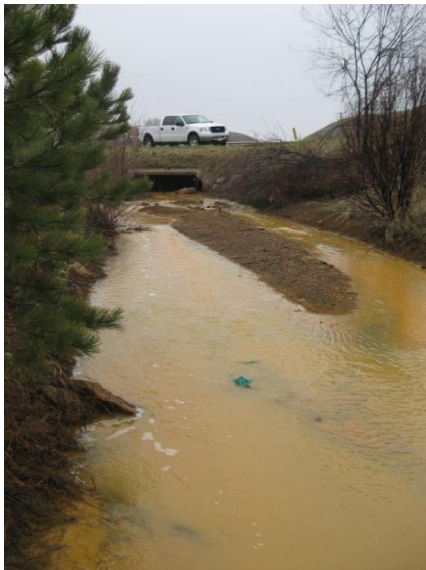
**1.1 Culvert under East Hunter Road at north end of Sand Coulee.**

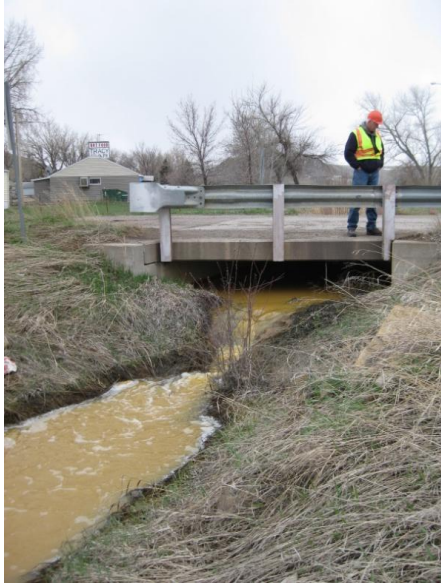
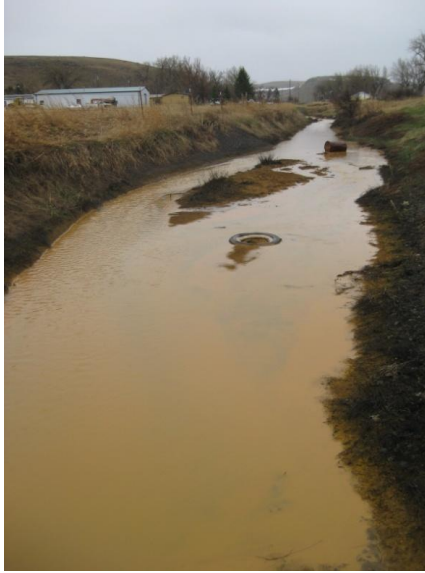
**1.8 Tracy Culverts. Plugged. Sand Coulee Creek below Tracy clogged with metal precipitates.**  
See mile 5.0 for Stockett to Tracy stream segment.

**1.9** Tracy Bridge. County road bridge across Sand Coulee Creek. Access to community of Tracy. Last photo shows condition of Sand Coulee Creek below county bridge into Tracy.
